# **Amulsar Gold Project: Overview of Concerns with the Amulsar Gold Project, Potential Consequences, and Recommendations**

**Report prepared by:  
Blue Minerals Consultancy  
Buka Environmental  
Clear Coast Consulting**

**January 2018**

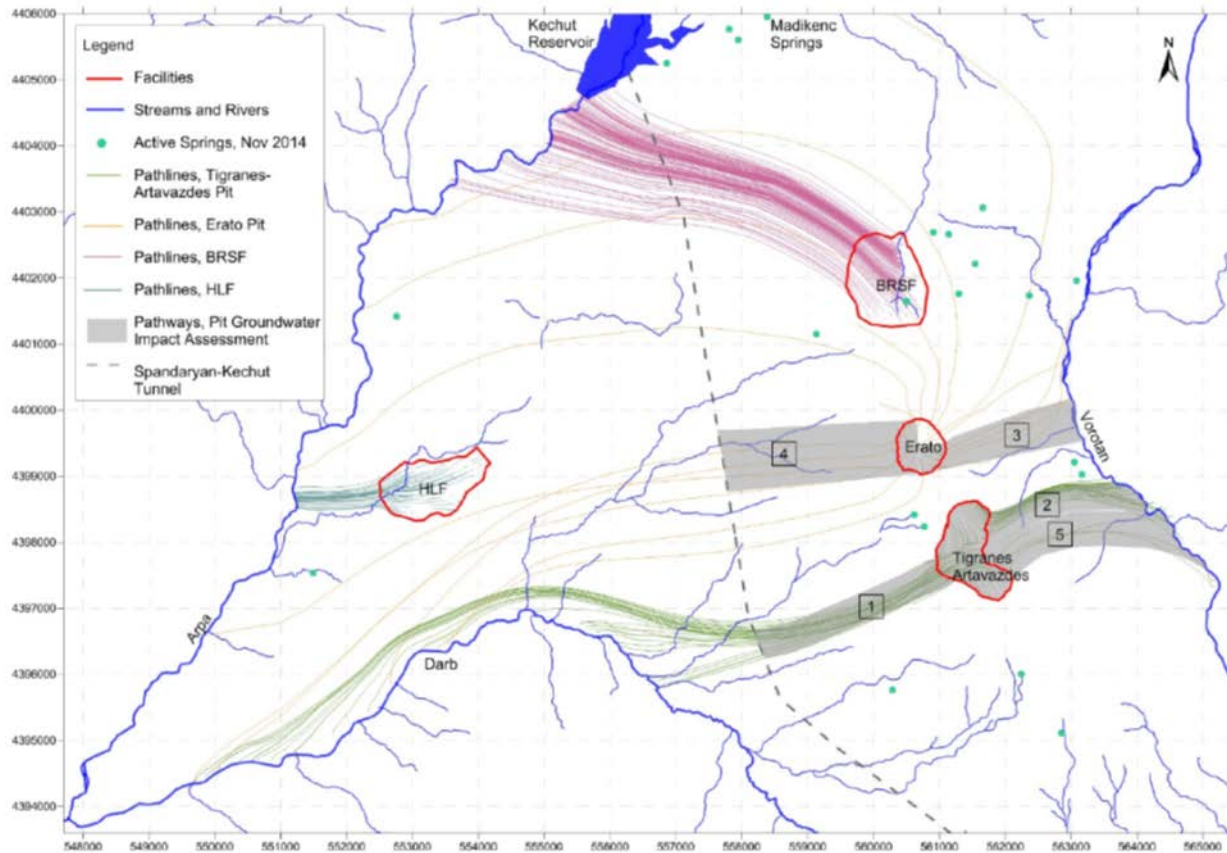
**Figure 1. Groundwater flow paths during post-closure.** Flow paths for water and contaminants from the barren rock storage facility (BRSF; waste rock dump), the heap leach facility (HLF; where gold is extracted from ore using a cyanide solution), and the open pits (Erato, Tigranes, Artavazdes; where ore and wastes are extracted) to the Arpa, Darb, and Vorotan rivers; springs; the Spandaryan-Kechut Tunnel; and the Kechut Reservoir are shown as colored lines (different colors for different mine sources). Flow paths from the Erato Pit (in yellow), which will not be backfilled, reach nearly all receptors, including the Arpa River upstream of the Kechut Reservoir. Gray numbered flow paths represent flow paths from the pits evaluated in Golder Associates (2014a). Note that the groundwater model used to identify the flow paths did not consider the abundant faults in the area that could bring contaminants more quickly, and with less dilution, to unanticipated receptor locations (Golder Associates, 2014b).
